Appliance part#
 225479

Description
 Low temperature oven

Bill of materials (BOM)

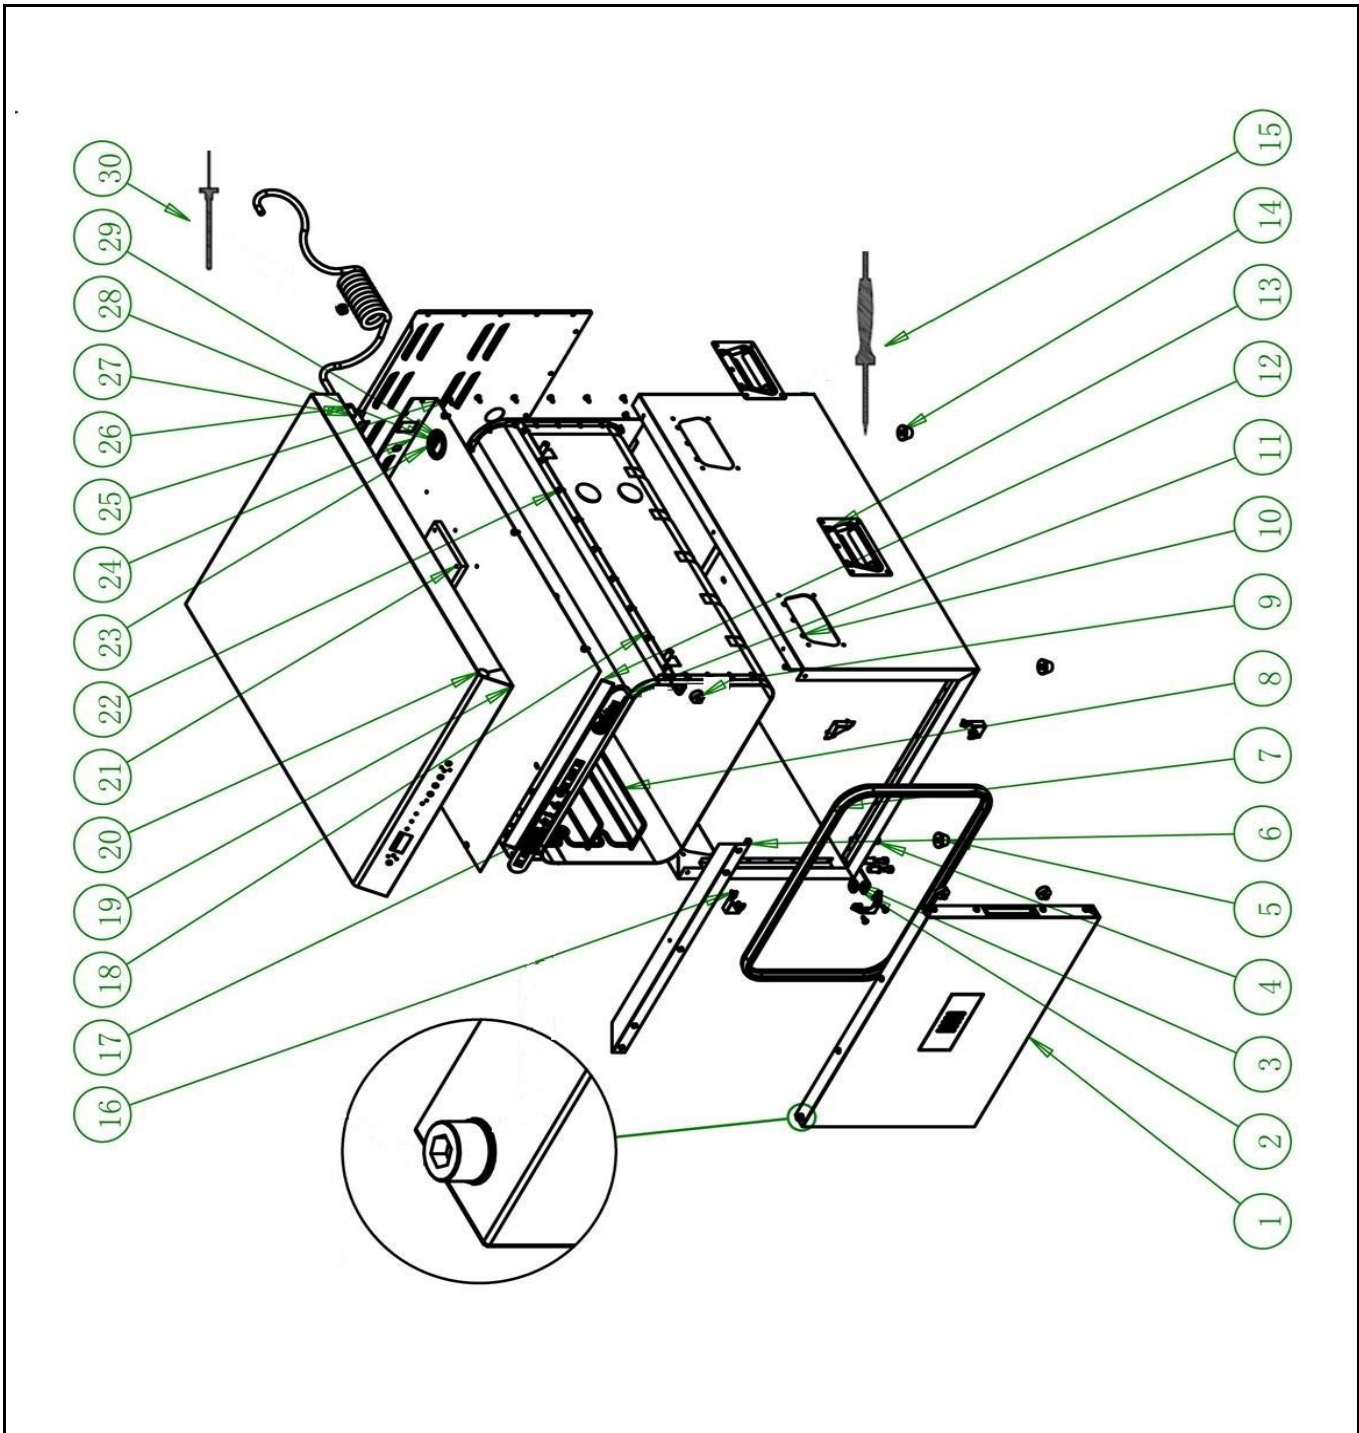
Drawing

Item	Description	Part#	Quantity	Remark	Picture
1	Door complete	932636	1		
2	Bottom hinge	n/a	1		
3	Spacer brass	934715	2		
4	Screw	n/a	8		
5	Feet	934722	4		
6	Bracket	n/a	1		
7	Door gasket	934739	1		
8	Lateral support left/right	934746	2		
9	Bolt lateral support	934807	4		
10	Outer housing	n/a	1		
11	Display sticker	931486	1		
12	Display pcb	934760	1		
13	Handle	934777	4		
14	Socket-head screw	n/a	4		
15	Probe	934791	1		
16	Bracket	n/a	2		
17	Screw 4,2 x 12	n/a	28		
18	Element 1200W	n/a	1		
19	Top cover	n/a	1		
20	Cap	n/a	2		
21	Main PCB	934784	1		
22	Bracket	n/a	2		
23	Gasket	n/a	1		
24	Bracket	n/a	1		
25	Screw 4,2 x 12	n/a	23		
26	Power cord	202289	1		
26a	Power cord reatainer	931066	1	Not shown on exploded view	
27	Bracket	n/a	1		
28	Back cover	n/a	1		
29	Switch	205426	1		
30	Probe oven chamber	934814	1
